**Flood Control Project Maintenance
Levee Inspections**

Maintenance Issue Types Only, Levee Inspection Report By Mile - Spring 2017

American River Flood Control District

Waterway	Bank	Unit Miles	Inspection Start/End	Inspector
Unit No. 01 Arcade Creek	Left	2.08	03/15/2017 05/03/2017	Maksim Khashchuk

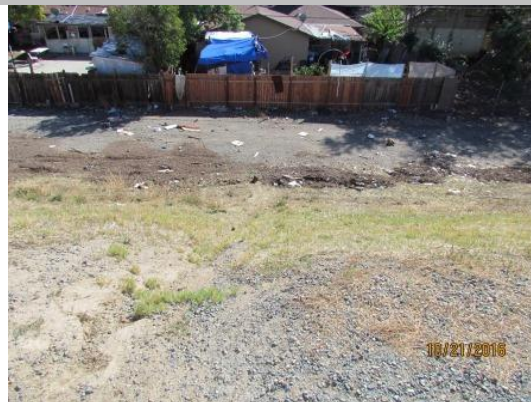
Photo 1 of 2 : SP_2017_NA0001_51_81_20170313_00048.jpg

LM Start	0.46	Rating **	M	Issue No.	81
LM End	0.46	Issue Type +	Ma	Location *	LS
Category	Earthen Levee			GPS Latitude/Longitude	
				Start	End
Item	Slope Stability			38.623101 °	38.623101 °
				-121.460573 °	-121.460573 °
DWR ID	DWR_NA0001_01_f_2015_81				
Comment Code					
S2 : Repair the levee slope damaged by foot traffic and prevent access where possible.					
Inspector Comment

View of the landside levee slope damaged by foot traffic. Fall 2016.

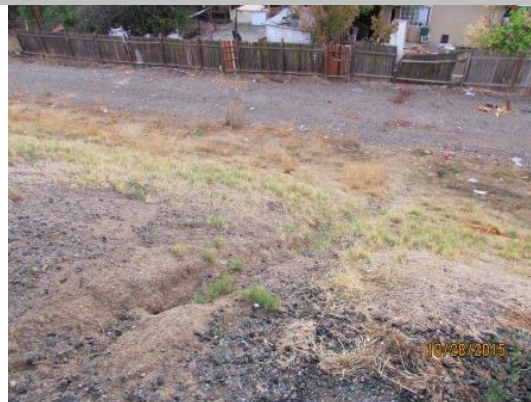
Photo 2 of 2 : SP_2017_NA0001_51_81_20170313_00049.jpg

View of the landside levee slope damaged by foot traffic.

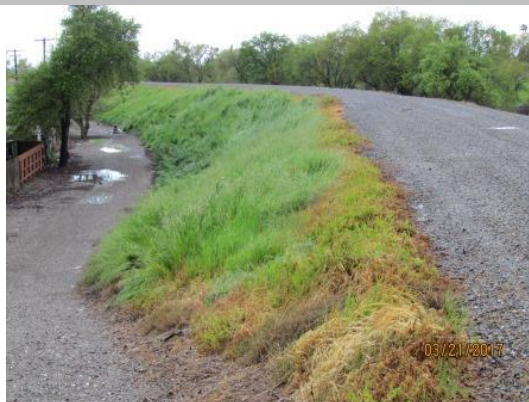
Photo 1 of 1 : SP_2017_NA0001_51_83_20170406_00096.jpg

LM Start	0.69	Rating **	M	Issue No.	83
LM End	0.96	Issue Type +	Ma	Location *	LS
Category	Earthen Levee			GPS Latitude/Longitude	
				Start	End
Item	Vegetation			38.623732 °	38.625096 °
				-121.456566 °	-121.452067 °
DWR ID	DWR_NA0001_01_s_2017_83				
Comment Code					
V1 : Control annual grass and weeds on the levee slopes and easements.					
Inspector Comment

View of the vegetation on the levee slope.

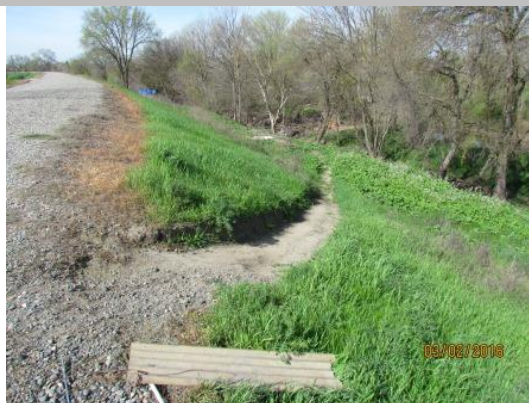
Photo 1 of 1 : SP_2017_NA0001_51_60_20170313_00039.jpg

LM Start	1.00	Rating **	M	Issue No.	60
LM End	1.00	Issue Type +	Ma	Location *	WS
Category	Earthen Levee			GPS Latitude/Longitude	
				Start	End
Item	Slope Stability			38.625161 °	38.625161 °
				-121.451302 °	-121.451302 °
DWR ID	DWR_NA0001_01_f_2015_60				
Comment Code					
S2 : Repair the levee slope damaged by foot traffic and prevent access where possible.					
Inspector Comment					
Backfill the cut made by the footpath.

View of the foot path on the waterside levee slope.

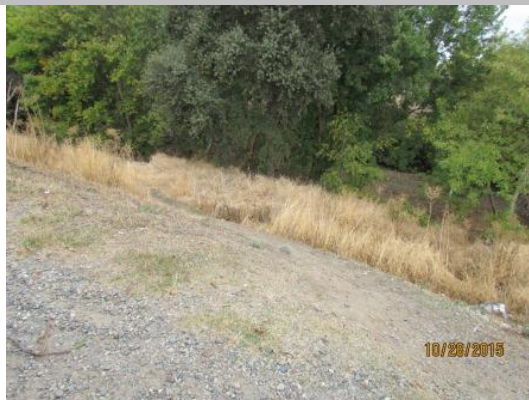
Photo 1 of 1 : SP_2017_NA0001_51_76_20170313_00047.jpg

LM Start	1.05	Rating **	M	Issue No.	76
LM End	1.05	Issue Type +	Ma	Location *	WS
Category	Earthen Levee			GPS Latitude/Longitude	
				Start	End
Item	Slope Stability			38.625069 °	38.625069 °
				-121.450360 °	-121.450360 °
DWR ID	DWR_NA0001_01_f_2015_76				
Comment Code					
S2 : Repair the levee slope damaged by foot traffic and prevent access where possible.					
Inspector Comment

View of the waterside levee slope damaged by foot traffic.

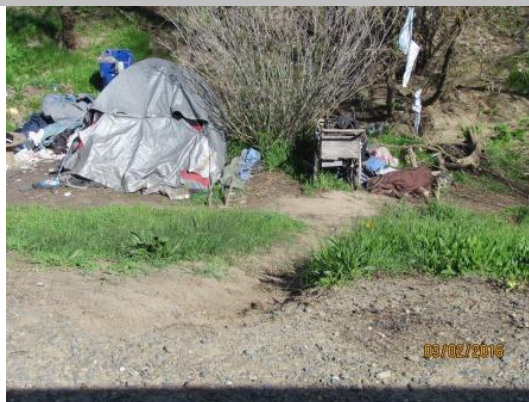
Photo 1 of 1 : SP_2017_NA0001_51_82_20170313_00050.jpg

LM Start	1.15	Rating **	A/W	Issue No.	82
LM End	1.15	Issue Type +	Ma	Location *	WS
Category	Earthen Levee			GPS Latitude/Longitude	
				Start	End
Item	Slope Stability			38.624866 °	38.624866 °
				-121.448555 °	-121.448555 °
DWR ID	DWR_NA0001_01_s_2016_82				
Comment Code					
S2 : Repair the levee slope damaged by foot traffic and prevent access where possible.					
Inspector Comment					
Homeless have created foot path.

View of the waterside levee slope erosion.

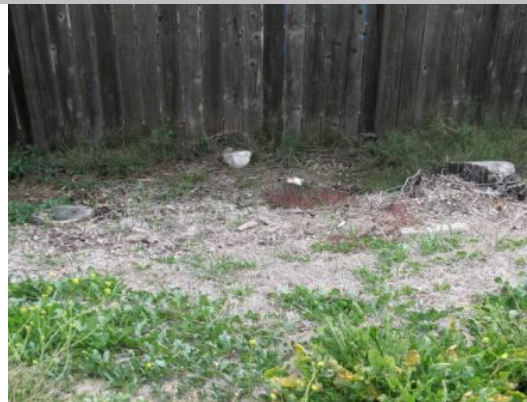
Photo 1 of 1 : SP_2017_NA0001_51_178_20170313_00059.jpg

11/17/2011 Two stumps at levee toe.

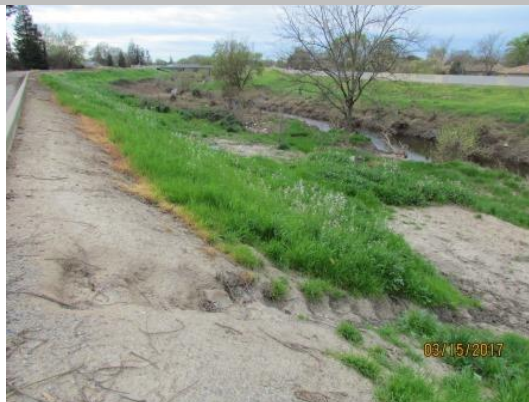
Photo 1 of 1 : SP_2017_NA0001_51_75_20170327_00094.jpg

LM Start	1.48	Rating **	M	Issue No.	75
LM End	1.48	Issue Type +	Ma	Location *	WS
Category	Earthen Levee			GPS Latitude/Longitude	
				Start	End
Item	Slope Stability			38.626912 °	38.626912 °
				-121.443229 °	-121.443229 °
DWR ID	DWR_NA0001_01_s_2017_75				
Comment Code					
S2 : Repair the levee slope damaged by foot traffic and prevent access where possible.					
Inspector Comment					
Stairs dug into waterside levee slope.

View of the stairs in the levee slope, looking downstream.

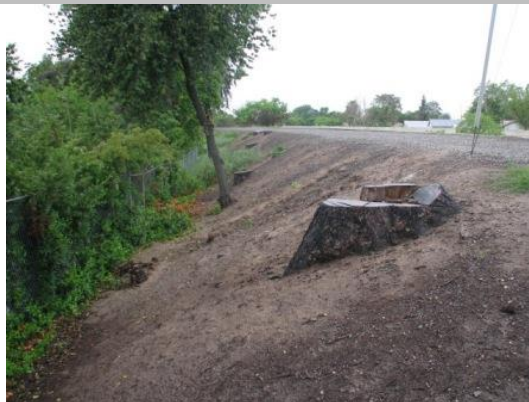
Photo 1 of 1 : SP_2017_NA0001_51_56_20170313_00035.jpg

LM Start	1.51	Rating **	N	Issue No.	56
LM End	1.52	Issue Type +	Ma	Location *	LS
Category	Earthen Levee			GPS Latitude/Longitude	
				Start	End
Item	Trim / Thin Trees			38.627180 °	38.627224 °
				-121.442718 °	-121.442515 °
DWR ID	DWR_NA0001_01_s_2012_56				
Comment Code					
T5 : Tree stumps.					
Inspector Comment					
4 stumps 14 to 30 Inches in diameter.

Several large stumps on levee slope.

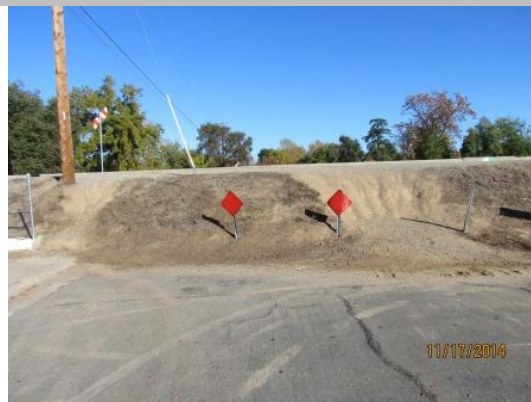
Photo 1 of 1 : SP_2017_NA0001_51_54_20170313_00034.jpg

LM Start	1.58	Rating **	A/W	Issue No.	54
LM End	1.58	Issue Type +	Ma	Location *	LS
Category	Earthen Levee			GPS Latitude/Longitude	
				Start	End
Item	Slope Stability			38.627251 °	38.627251 °
				-121.441460 °	-121.441460 °
DWR ID	DWR_NA0001_01_s_2012_54				
Comment Code					
S2 : Repair the levee slope damaged by foot traffic and prevent access where possible.					
Inspector Comment

Slope stability due to foot traffic needs to be monitored.

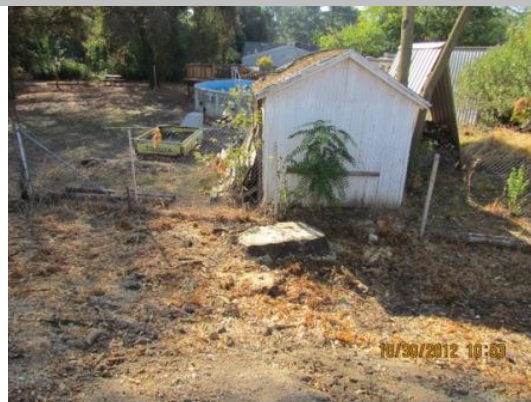
Photo 1 of 1 : SP_2017_NA0001_51_31_20170313_00025.jpg

LM Start	1.61	Rating **	N	Issue No.	31
LM End	1.61	Issue Type +	Ma	Location *	LS
Category	Earthen Levee			GPS Latitude/Longitude	
				Start	End
Item	Trim / Thin Trees			38.627191 °	38.627191 °
				-121.440861 °	-121.440861 °
DWR ID	DWR_NA0001_01_f_2012_31				
Comment Code					
T5 : Tree stumps.					
Inspector Comment

View of large tree stump at levee toe.

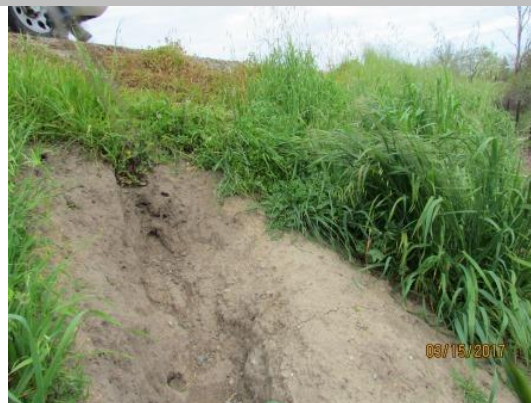
Photo 1 of 1 : SP_2017_NA0001_51_65_20170327_00092.jpg

LM Start	1.69	Rating **	M	Issue No.	65
LM End	1.69	Issue Type +	Ma	Location *	LS
Category	Earthen Levee			GPS Latitude/Longitude	
				Start	End
Item	Animal Control			38.627585 °	38.627585 °
				-121.439561 °	-121.439561 °
DWR ID	DWR_NA0001_01_f_2015_65				
Comment Code					
A3 : No rodents visible, but rodent burrows visible; need to backfill and compact or grout burrows.					
Inspector Comment					
Area shows signs of rodent damage.

View of the animal activity on the levee slope.

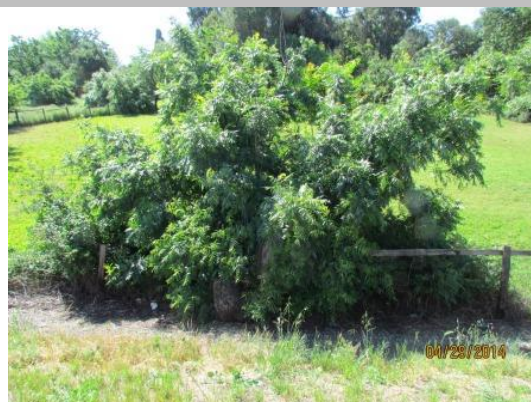
Photo 1 of 1 : SP_2017_NA0001_51_48_20170313_00031.jpg

LM Start	1.69	Rating **	M	Issue No.	48
LM End	1.69	Issue Type +	Ma	Location *	LS
Category	Earthen Levee			GPS Latitude/Longitude	
				Start	End
Item	Vegetation			38.627594 °	38.627594 °
				-121.439540 °	-121.439540 °
DWR ID	DWR_NA0001_01_s_2014_48				
Comment Code					
V2 : Remove the wild growth other than native grasses from the levee slopes.					
Inspector Comment					
Tree obstructing visibility and access.

View of the overgrown tree at the landside levee toe.

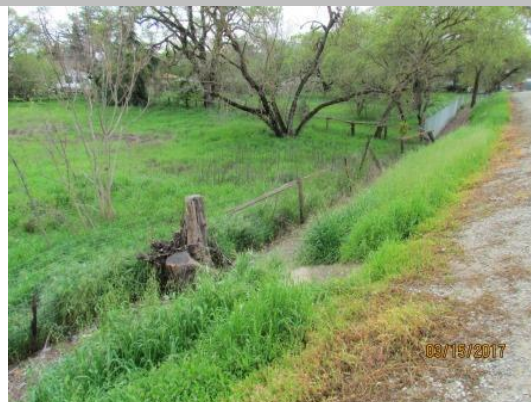
Photo 1 of 1 : SP_2017_NA0001_51_74_20170327_00093.jpg

LM Start	1.69	Rating **	N	Issue No.	74
LM End	1.69	Issue Type +	Ma	Location *	LS
Category	Earthen Levee			GPS Latitude/Longitude	
				Start	End
Item	Trim / Thin Trees			38.627607 °	38.627607 °
				-121.439545 °	-121.439545 °
DWR ID	DWR_NA0001_01_s_2017_74				
Comment Code					
T5 : Tree stumps.					
Inspector Comment					
24 inch large tree stump at levee toe.

View of the tree stump at the levee toe.

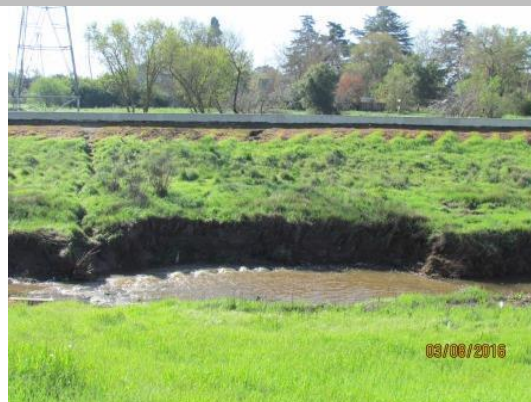
Photo 1 of 1 : SP_2017_NA0001_51_84_20170313_00051.jpg

LM Start	1.74	Rating **	M	Issue No.	84
LM End	1.74	Issue Type +	Ma	Location *	WS
Category	Rivers, Channels & Designated Floodways			GPS Latitude/Longitude	
				Start	End
Item	Erosion / Bank Caving			38.627882 °	38.627882 °
				-121.438602 °	-121.438602 °
DWR ID	DWR_NA0001_01_s_2017_84				
Comment Code					
Inspector Comment					
The LMA is making plans to repair this site soon. Erosion has progressed a little bit as of Spring 2017.

View of the erosion on the waterside levee berm.

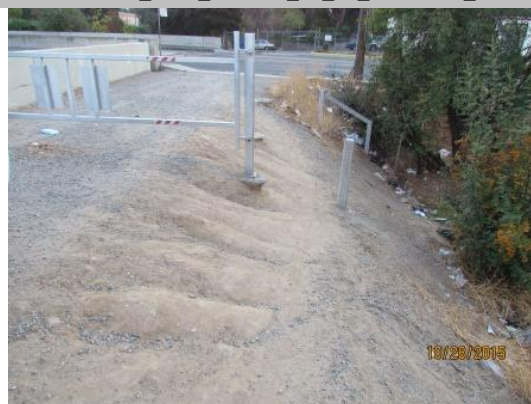
Photo 1 of 1 : SP_2017_NA0001_51_46_20170313_00029.jpg

LM Start	2.07	Rating **	M	Issue No.	46
LM End	2.07	Issue Type +	Ma	Location *	LS
Category	Earthen Levee			GPS Latitude/Longitude	
				Start	End
Item	Slope Stability			38.627246 °	38.627246 °
				-121.432673 °	-121.432673 °
DWR ID	DWR_NA0001_01_f_2015_46				
Comment Code					
S2 : Repair the levee slope damaged by foot traffic and prevent access where possible.					
Inspector Comment					
LMA will fix this site after the levee improvement project is completed.

View of the damaged landside levee slope.

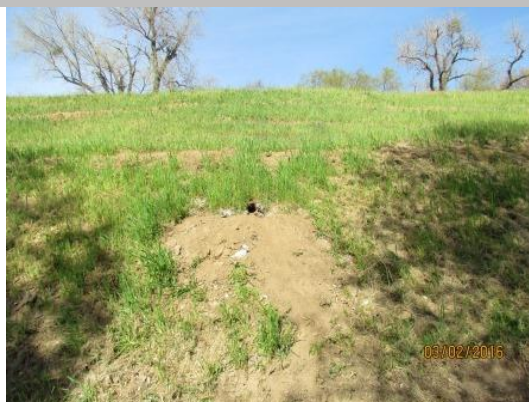
Photo 1 of 2 : SP_2017_NA0001_52_28_20170313_00008.jpg

View of the rodent holes on the landside levee slope.

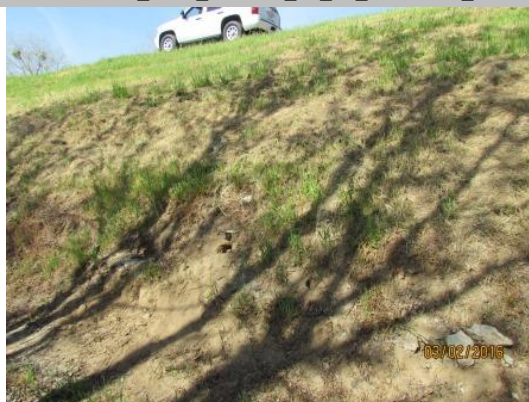
Photo 2 of 2 : SP_2017_NA0001_52_28_20170313_00009.jpg

Another view of the rodent holes on the landside levee slope.

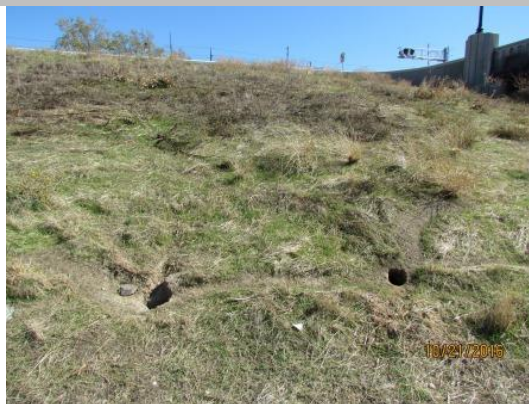
Photo 1 of 1 : SP_2017_NA0001_52_24_20170313_00004.jpg

View of the rodent holes in the waterside levee slope.

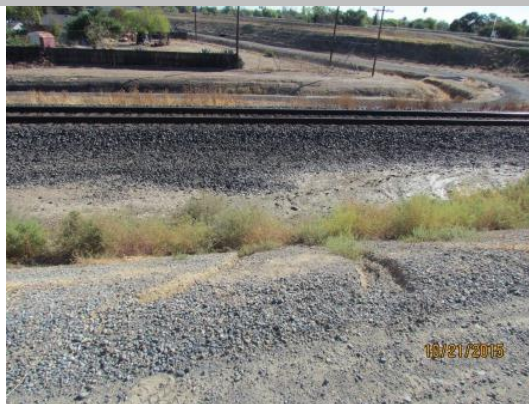
Photo 1 of 1 : SP_2017_NA0001_52_26_20170313_00006.jpg

LM Start	1.40	Rating **	M	Issue No.	26
LM End	1.40	Issue Type +	Ma	Location *	LS
Category	Earthen Levee			GPS Latitude/Longitude	
				Start	End
Item	Slope Stability			38.621054 °	38.621054 °
				-121.468008 °	-121.468008 °
DWR ID	DWR_NA0001_02_f_2015_26				
Comment Code					
S3 : Repair the levee slope damaged by vehicle traffic and prevent access where possible.					
Inspector Comment

View of the damaged landside levee slope.

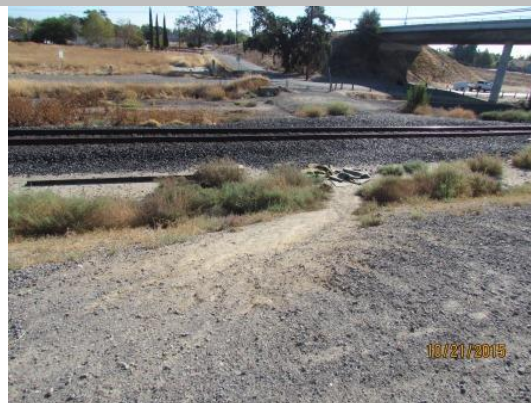
Photo 1 of 1 : SP_2017_NA0001_52_25_20170313_00005.jpg

LM Start	2.05	Rating **	M	Issue No.	25
LM End	2.05	Issue Type +	Ma	Location *	LS
Category	Earthen Levee			GPS Latitude/Longitude	
				Start	End
Item	Slope Stability			38.630425 °	38.630425 °
				-121.469807 °	-121.469807 °
DWR ID	DWR_NA0001_02_f_2015_25				
Comment Code					
S2 : Repair the levee slope damaged by foot traffic and prevent access where possible.					
Inspector Comment

View of the landside levee slope damaged by foot traffic.

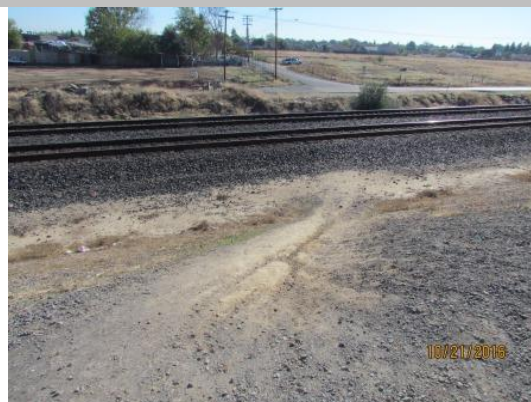
Photo 1 of 1 : SP_2017_NA0001_52_27_20170313_00007.jpg

LM Start	2.59	Rating **	M	Issue No.	27
LM End	2.59	Issue Type +	Ma	Location *	LS
Category	Earthen Levee			GPS Latitude/Longitude	
				Start	End
Item	Slope Stability			38.638109 °	38.638109 °
				-121.471254 °	-121.471254 °
DWR ID	DWR_NA0001_02_f_2016_27				
Comment Code					
S2 : Repair the levee slope damaged by foot traffic and prevent access where possible.					
Inspector Comment

View of the foot path on the landside levee slope.

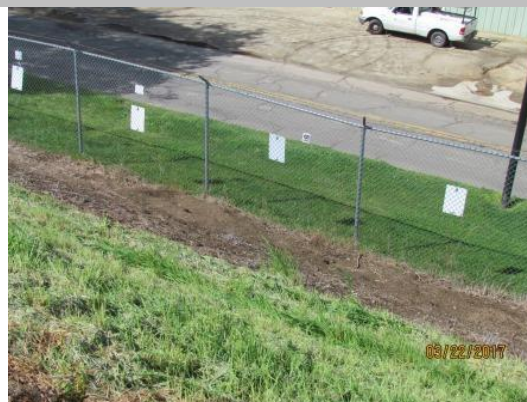
Photo 1 of 1 : SP_2017_NA0001_490_23_20170406_00035.jpg

View of the rodent burrow at the levee toe.

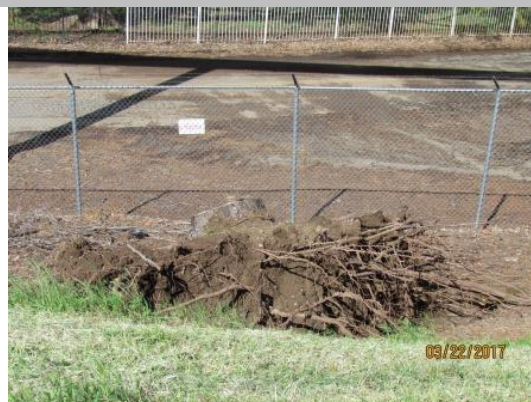
Photo 1 of 1 : SP_2017_NA0001_490_21_20170406_00034.jpg

View of the tree stump at the levee toe.

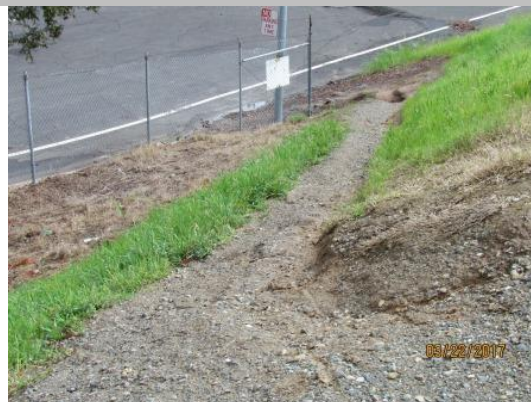
Photo 1 of 1 : SP_2017_NA0001_490_9_20170406_00033.jpg

LM Start	1.82	Rating **	M	Issue No.	9
LM End	1.82	Issue Type +	Ma	Location *	LS
Category	Earthen Levee			GPS Latitude/Longitude	
				Start	End
Item	Slope Stability			38.595700 °	38.595700 °
				-121.448198 °	-121.448198 °
DWR ID	DWR_NA0001_03_s_2012_9				
Comment Code					
S2 : Repair the levee slope damaged by foot traffic and prevent access where possible.					
Inspector Comment

View of the erosion on landside levee slope due to pedestrian traffic.

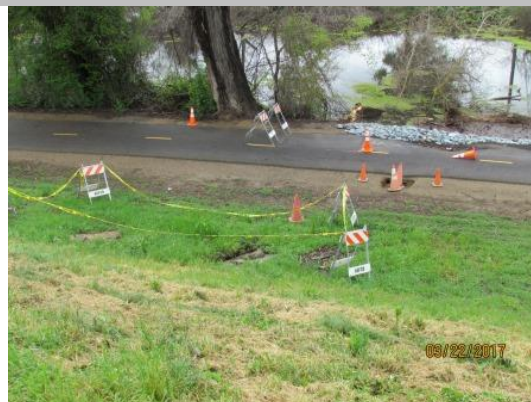
Photo 1 of 1 : SP_2017_NA0001_490_20_20170406_00032.jpg

LM Start	2.63	Rating **	M	Issue No.	20
LM End	2.63	Issue Type +	Ma	Location *	WS
Category	Earthen Levee			GPS Latitude/Longitude	
				Start	End
Item	Erosion / Bank Caving			38.594541 °	38.594541 °
				-121.462639 °	-121.462639 °
DWR ID	DWR_NA0001_03_s_2017_20				
Comment Code					
E2 : Schedule repair of erosion site prior to the next inspection.					
Inspector Comment					
Remove and backfill beaver den at waterside levee toe.

View of the beaver den at the waterside levee toe.

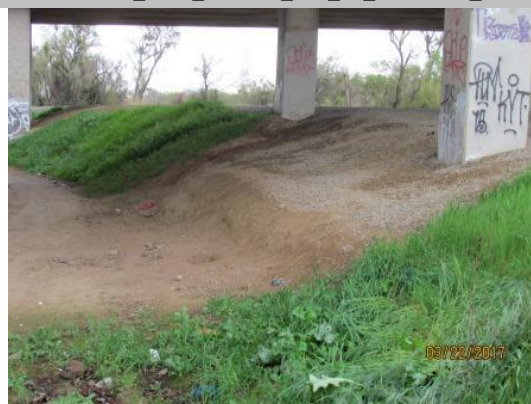
Photo 1 of 1 : SP_2017_NA0001_490_12_20170406_00031.jpg

LM Start	3.19	Rating **	M	Issue No.	12
LM End	3.19	Issue Type +	Ma	Location *	LS
Category	Earthen Levee			GPS Latitude/Longitude	
				Start	End
Item	Slope Stability			38.599395 °	38.599395 °
				-121.470434 °	-121.470434 °
DWR ID	DWR_NA0001_03_s_2017_12				
Comment Code					
S1 : Repair slope instability.					
Inspector Comment					
Add appropriate fill to bring slope back to grade.

View of the levee toe cut.

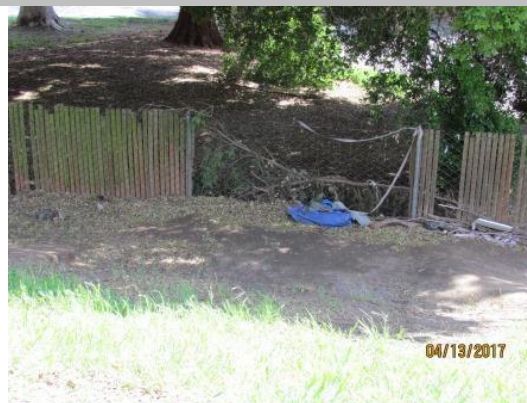
Photo 1 of 1 : SP_2017_NA0001_55_267_20170417_00280.jpg

LM Start	0.53	Rating **	M	Issue No.	267
LM End	0.53	Issue Type +	Ma	Location *	LS
Category	Earthen Levee			GPS Latitude/Longitude	
				Start	End
Item	Slope Stability			38.601163 °	38.601163 °
				-121.499866 °	-121.499866 °
DWR ID	DWR_NA0001_04_s_2017_267				
Comment Code					
S2 : Repair the levee slope damaged by foot traffic and prevent access where possible.					
Inspector Comment

View of the slope damaged by transients digging in the levee slope.

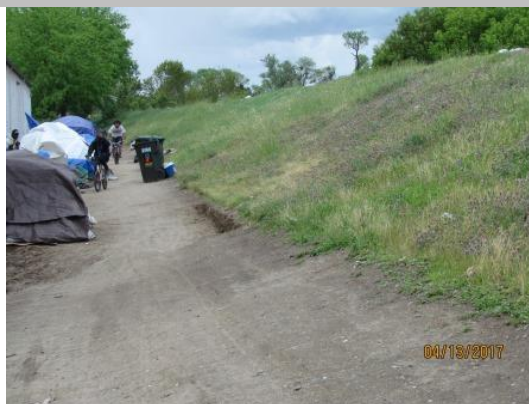
Photo 1 of 1 : SP_2017_NA0001_55_266_20170417_00278.jpg

LM Start	1.80	Rating **	M	Issue No.	266
LM End	1.80	Issue Type +	Ma	Location *	LS
Category	Earthen Levee			GPS Latitude/Longitude	
				Start	End
Item	Slope Stability			38.596876 °	38.596876 °
				-121.478390 °	-121.478390 °
DWR ID	DWR_NA0001_04_s_2017_266				
Comment Code					
S2 : Repair the levee slope damaged by foot traffic and prevent access where possible.					
Inspector Comment

View of the levee toe cut by the transients.

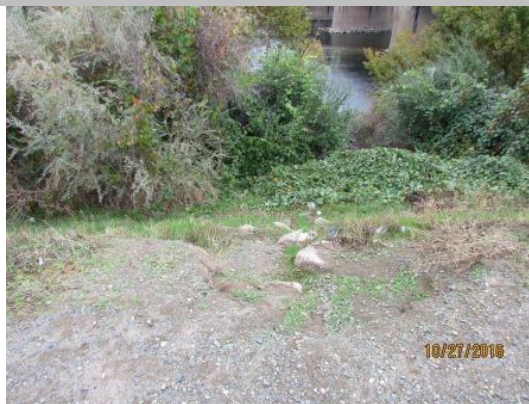
Photo 1 of 2 : SP_2017_NA0001_55_250_20170313_00190.jpg

LM Start	1.85	Rating **	A/W	Issue No.	250
LM End	1.85	Issue Type +	Ma	Location *	WS
Category	Earthen Levee			GPS Latitude/Longitude	
				Start	End
Item	Slope Stability			38.596220 °	38.596220 °
				-121.477713 °	-121.477713 °
DWR ID	DWR_NA0001_04_s_2016_250				
Comment Code					
S2 : Repair the levee slope damaged by foot traffic and prevent access where possible.					
Inspector Comment					
The erosion of the levee slope from the footpath appears to be stable at this time and should be monitored.

View of the footpath on the waterside levee slope, looking at the slope.

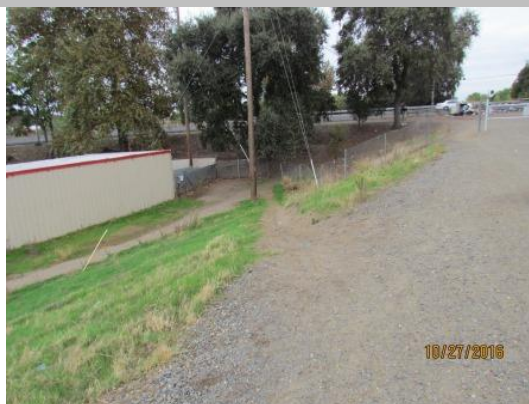
Photo 1 of 1 : SP_2017_NA0001_55_244_20170313_00187.jpg

LM Start	1.95	Rating **	A/W	Issue No.	244
LM End	1.95	Issue Type +	Ma	Location *	LS
Category	Earthen Levee			GPS Latitude/Longitude	
				Start	End
Item	Slope Stability			38.595040 °	38.595040 °
				-121.476882 °	-121.476882 °
DWR ID	DWR_NA0001_04_f _ 2015_244				
Comment Code					
S2 : Repair the levee slope damaged by foot traffic and prevent access where possible.					
Inspector Comment					
The erosion of the levee slope from the footpath appears to be stable at this time and should be monitored.

View of the footpath on the landside levee slope.

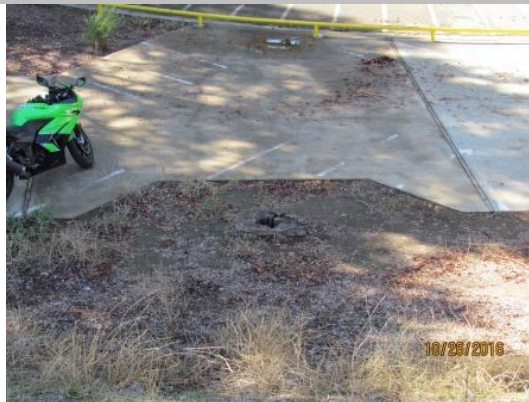
Photo 1 of 1 : SP_2017_NA0001_55_238_20170313_00184.jpg

View of the tree stump at the landside levee toe.

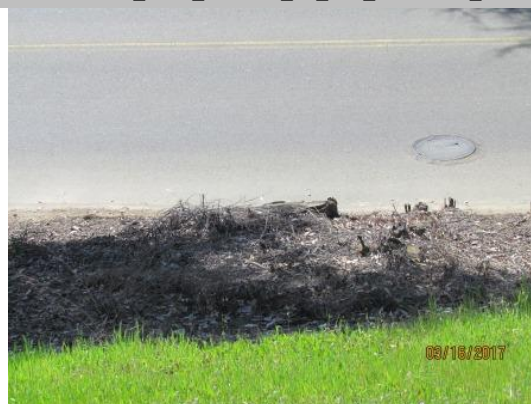
Photo 1 of 1 : SP_2017_NA0001_55_256_20170406_00260.jpg

View of the stump at the levee toe.

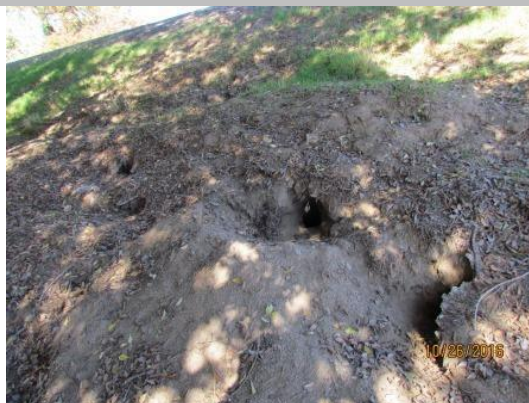
Photo 1 of 2 : SP_2017_NA0001_55_240_20170313_00185.jpg

View of a rodent burrows at the landside levee toe.

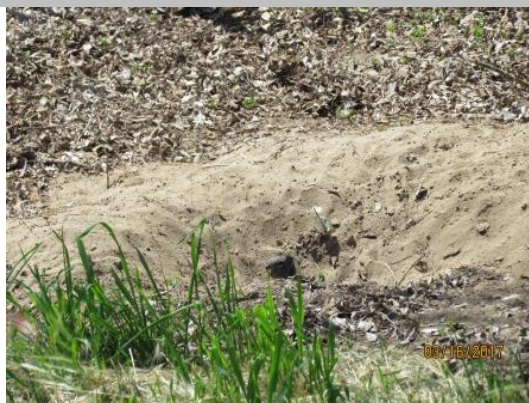
Photo 2 of 2 : SP_2017_NA0001_55_240_20170406_00259.jpg

Another view of the rodent burrow at the levee toe.

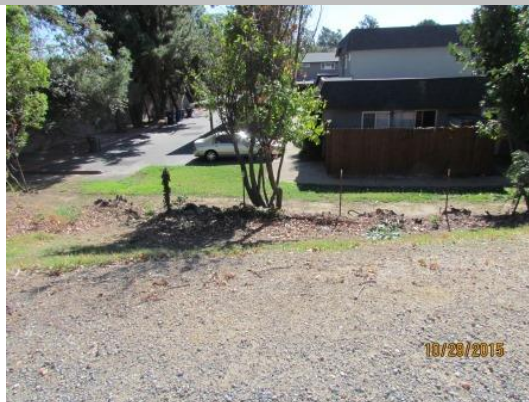
Photo 1 of 1 : SP_2017_NA0001_55_230_20170313_00179.jpg

View of the multiple tree stumps at the landside levee toe.

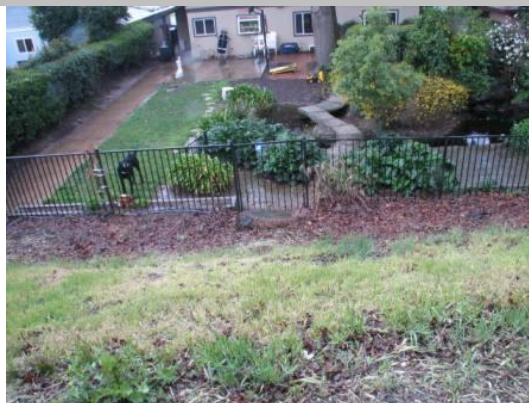
Photo 1 of 1 : SP_2017_NA0001_55_123_20170313_00106.jpg

03/16/2012 Large tree stump at levee toe.

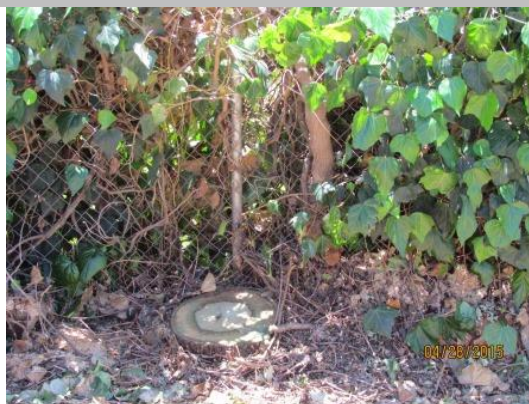
Photo 1 of 1 : SP_2017_NA0001_55_234_20170313_00180.jpg

View of the tree stump at the landside levee toe.

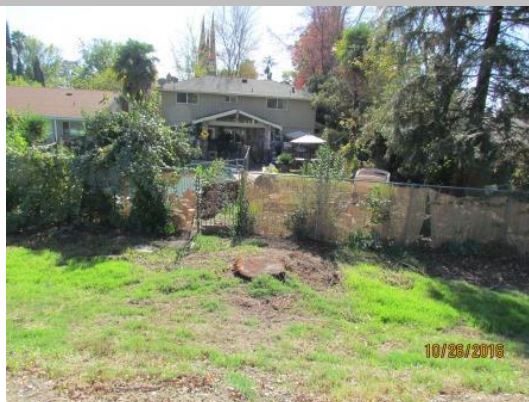
Photo 1 of 1 : SP_2017_NA0001_55_222_20170313_00174.jpg

View of the tree stump at the landside levee toe.

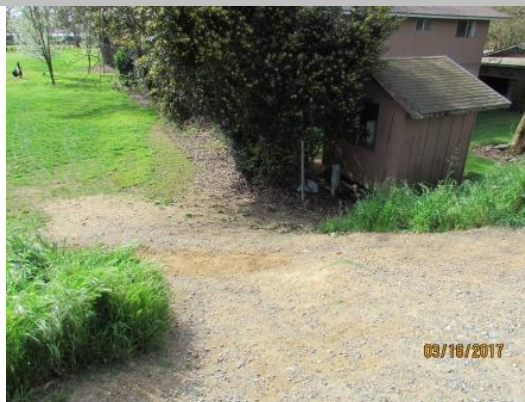
Photo 1 of 1 : SP_2017_NA0001_55_221_20170406_00253.jpg

View of the footpath on the levee slope.

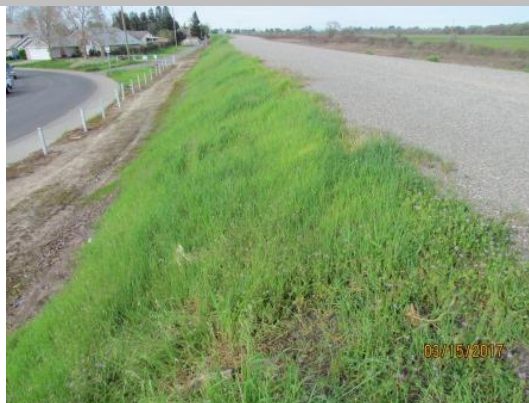
Photo 1 of 1 : SP_2017_NA0001_57_4_20170327_00007.jpg

View of the annual vegetation on the levee slope.

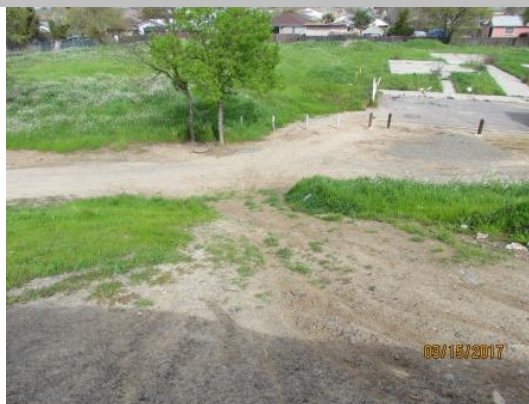
Photo 1 of 1 : SP_2017_NA0001_58_36_20170327_00045.jpg

View of the footpath on levee slope.

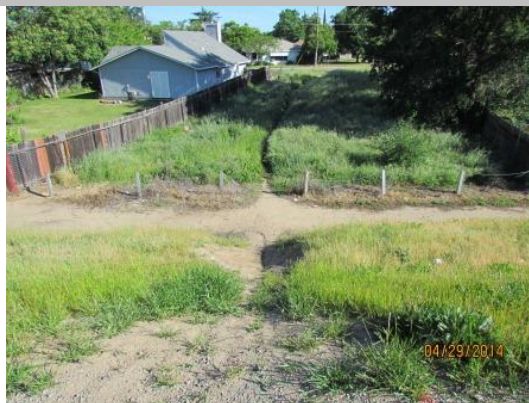
Photo 1 of 1 : SP_2017_NA0001_58_34_20170313_00026.jpg

View of the landside levee slope damaged by foot traffic.

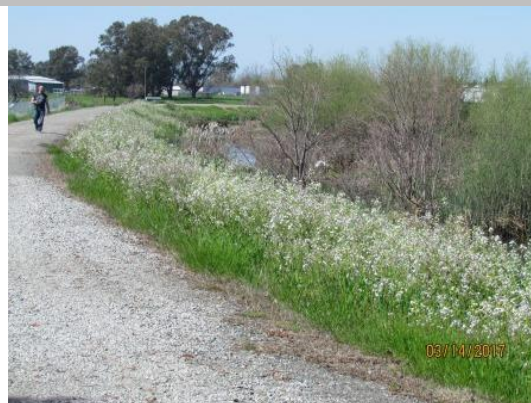
Photo 1 of 1 : SP_2017_NA0001_59_11_20170327_00015.jpg

View of the annual vegetation on the waterside levee slope.

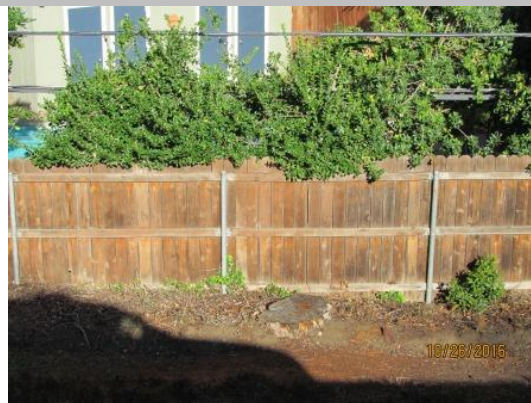
Photo 1 of 1 : SP_2017_NA0001_60_30_20170313_00010.jpg

View of the tree stump on the landside levee toe.

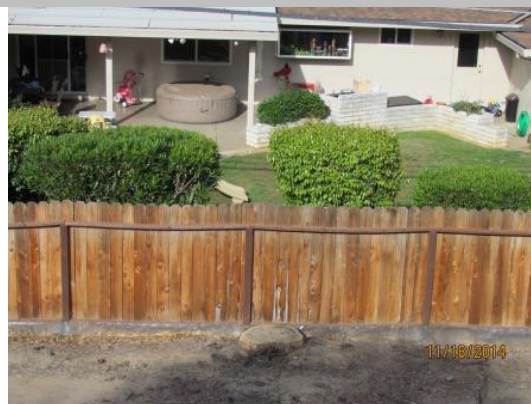
Photo 1 of 1 : SP_2017_NA0001_60_12_20170313_00003.jpg

View of the tree stump at the landside levee toe.

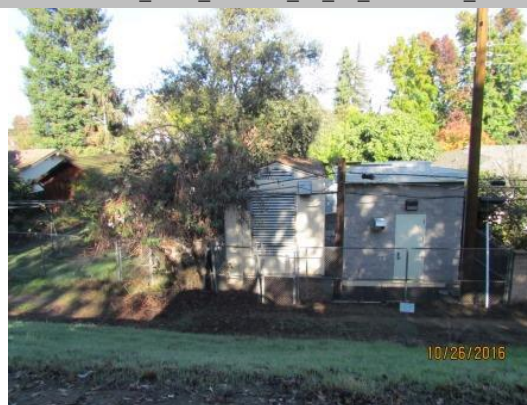
Photo 1 of 1 : SP_2017_NA0001_60_14_20170313_00004.jpg

Tree trunk at fence line.

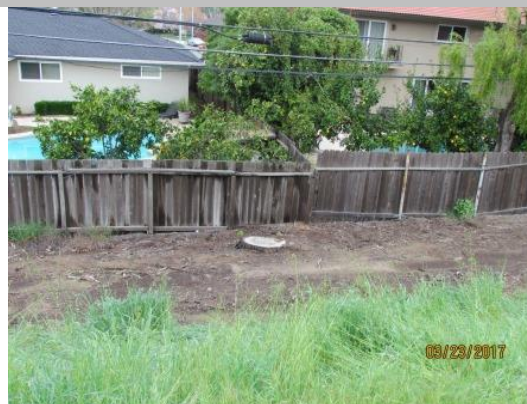
Photo 1 of 1 : SP_2017_NA0001_60_29_20170406_00046.jpg

View of the tree stump within the levee easement.

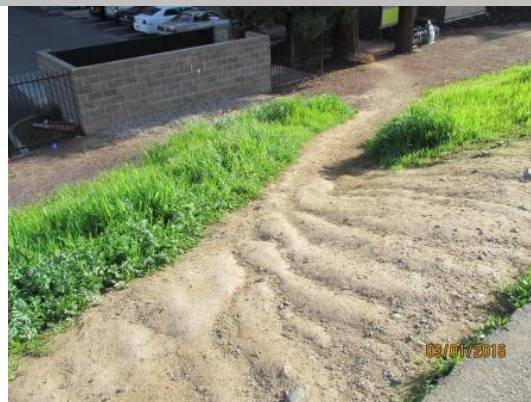
Photo 1 of 1 : SP_2017_NA0001_60_28_20170313_00009.jpg

View of the landside levee slope.

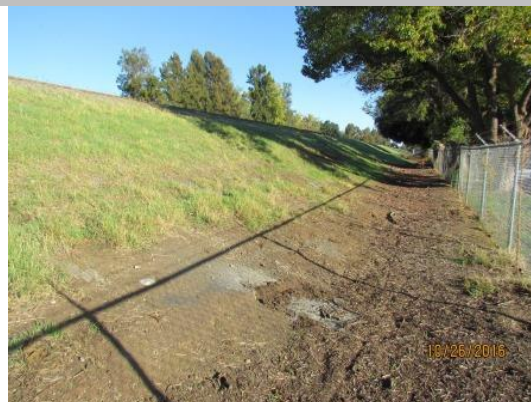
Photo 1 of 2 : SP_2017_NA0001_60_27_20170313_00008.jpg

View of the rodent holes on the landside levee slope.

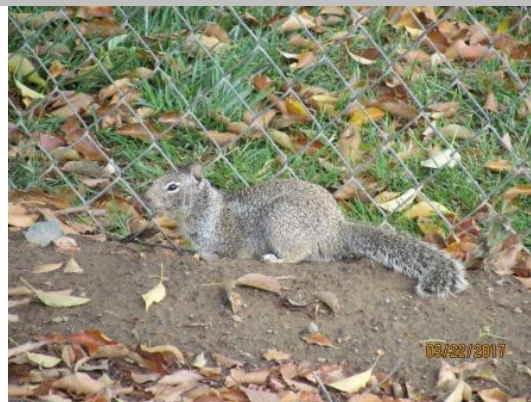
Photo 2 of 2 : SP_2017_NA0001_60_27_20170406_00045.jpg

View of the rodent at the levee toe causing levee damage.

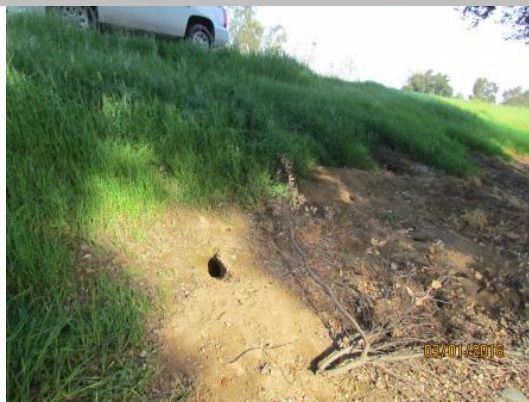
Photo 1 of 1 : SP_2017_NA0001_60_26_20170313_00007.jpg

View of the rodent holes in the landside levee slope.

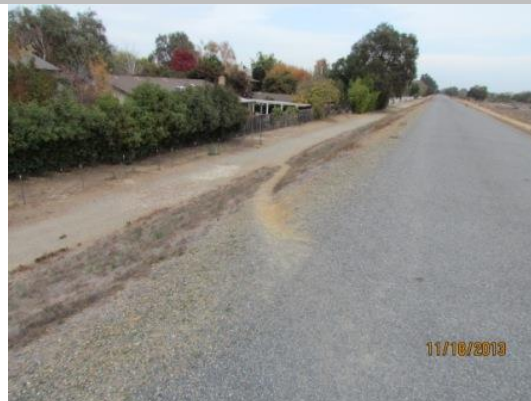
Photo 1 of 1 : SP_2017_NA0001_61_7_20170313_00001.jpg

View of the pathway on the landside levee slope.

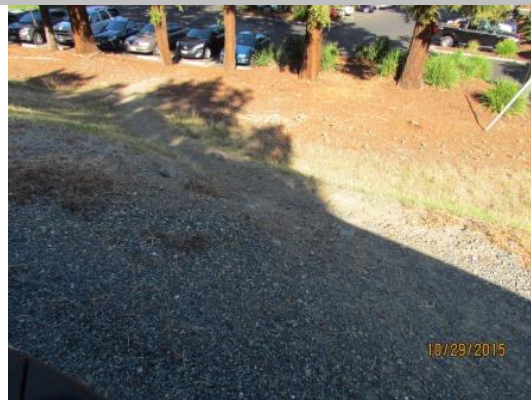
Photo 1 of 1 : SP_2017_NA0001_61_21_20170313_00003.jpg

View of the footpath on the landside levee slope.

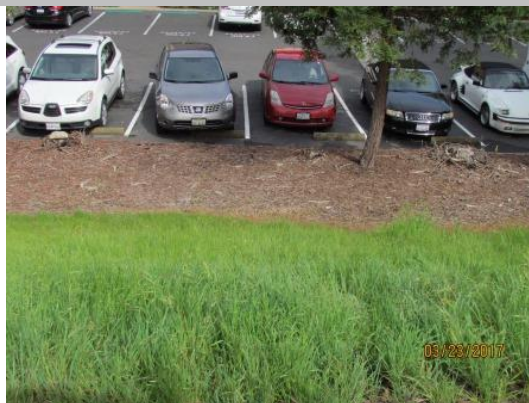
Photo 1 of 1 : SP_2017_NA0001_61_29_20170406_00047.jpg

View of the tree stump within the levee easement.

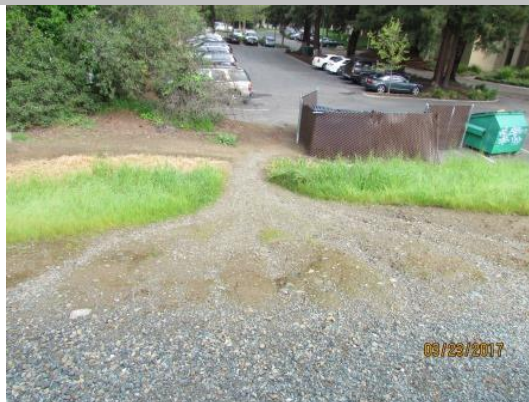
Photo 1 of 1 : SP_2017_NA0001_61_116_20170406_00046.jpg

View of the erosion on the landside levee slope caused by pedestrian foot traffic.

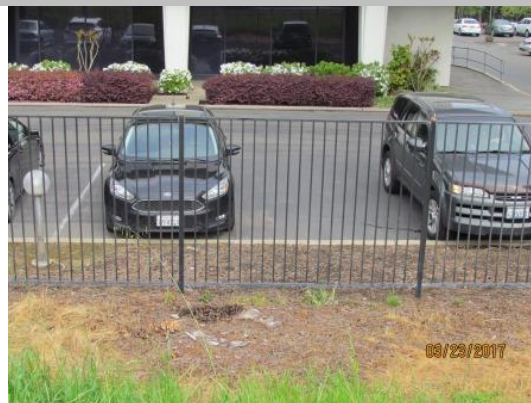
Photo 1 of 1 : SP_2017_NA0001_61_28_20170406_00045.jpg

View of the tree stump at the levee toe.

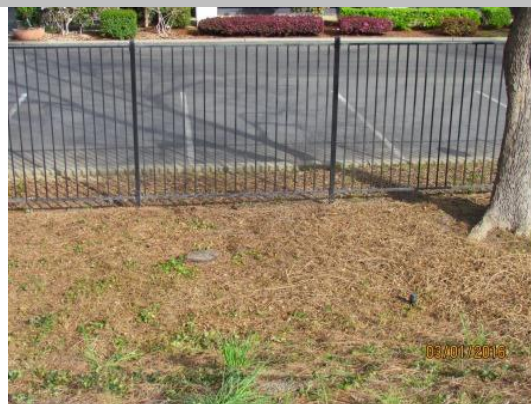
Photo 1 of 1 : SP_2017_NA0001_61_26_20170313_00005.jpg

View of the tree stump at the landside levee toe.

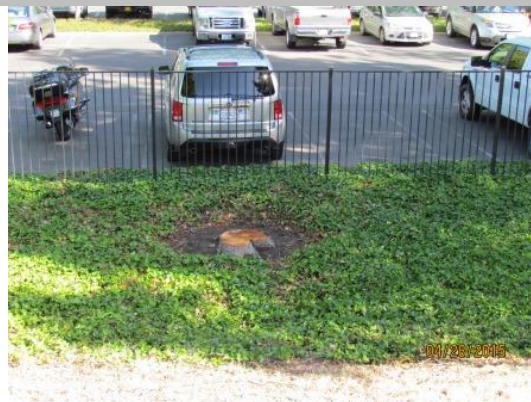
Photo 1 of 1 : SP_2017_NA0001_61_23_20170313_00004.jpg

View of the tree stump at the landside levee toe.

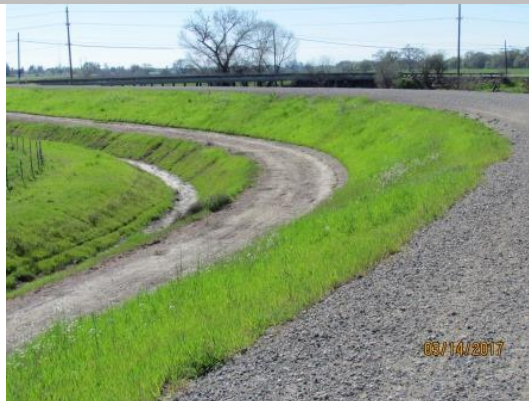
Photo 1 of 1 : SP_2017_NA0001_436_5_20170327_00009.jpg

View of the acceptable vegetation on the landside levee slope.

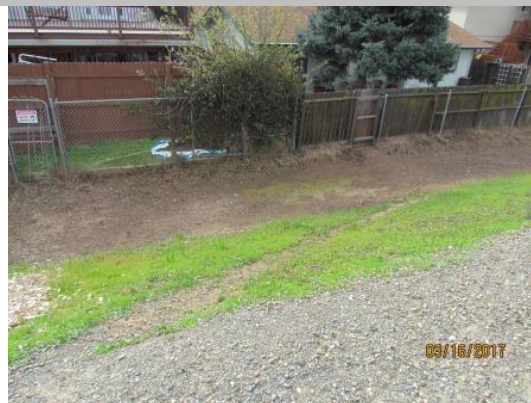
Photo 1 of 1 : SP_2017_NA0001_438_8_20170406_00014.jpg

View of the footpath on the levee slope.

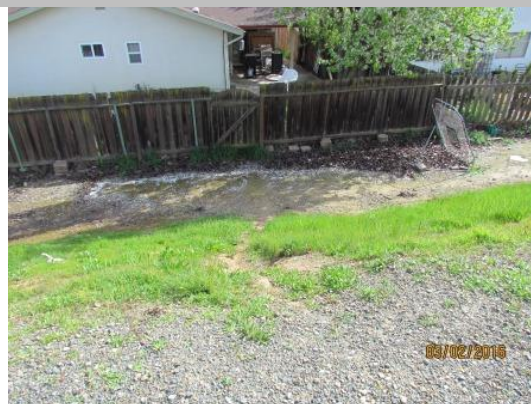
Photo 1 of 1 : SP_2017_NA0001_438_4_20170313_00004.jpg

View of the footpath on the landside levee slope.
